Series 2200/2220 - 1.0" & 2.0"

The information contained in this manual is about the 1.0" and 2.0" Norriseal Series 2200 and 2220 Control Valves. Please refer to separate manuals for all other controllers, positioners and their optional accessories.

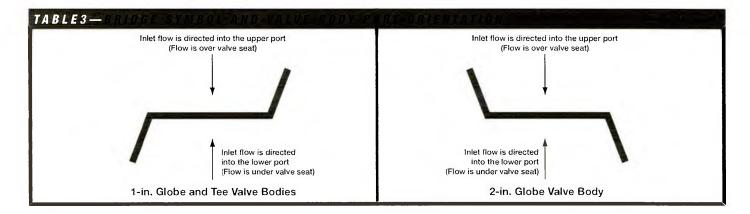
On the outside of the globe and tee valve bodies you will find a **BRIDGE SYMBOL** cast. This image repre-

sents the position of the internal cast web (or bridge) separating the lower port-flow passage from the upper port-flow passage. The Series 2200/2220 valve can be installed with the inlet fluid flow directed into the body's lower port ("flow under seat") or upper port ("flow over seat"). This is the reason a bridge symbol is used instead of a direction arrow. Issues regarding your valve's performance are often because of the direction fluid is flowing through the valve body. The illustrations below define how the bridge symbol geometry and the internal port orientation of the valve body work together.
